National Transportation Safety Board

Railroad Accident Brief

Train Collision with End of Track
Felton, California

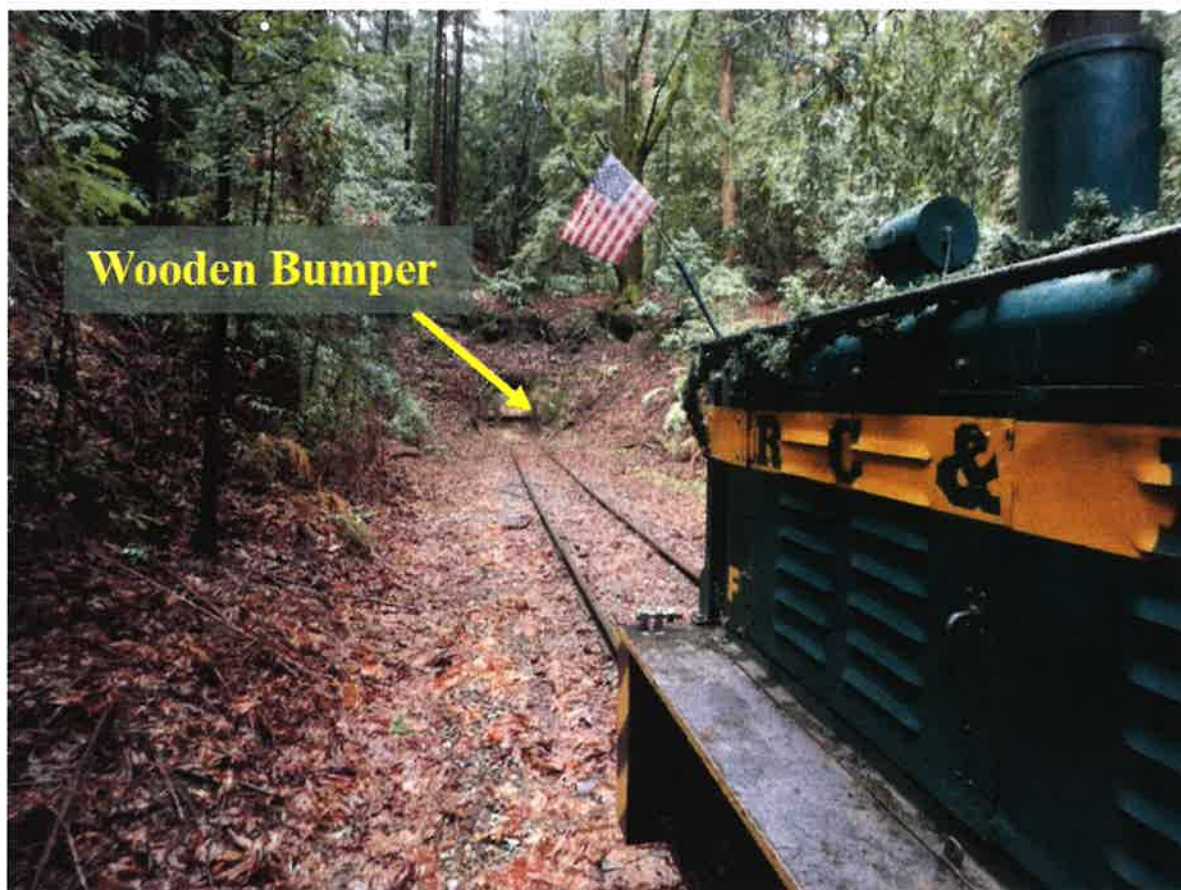
On December 28, 2015, about 11:55 a.m., Pacific standard time, a Roaring Camp & Big Trees Narrow Gauge Railroad (RCBT) tourist/excursion train struck a wooden bumper at the end of a switchback track in Felton, California.¹ The train had 39 passengers, six of whom received minor injuries. The weather at the time of the accident was partly sunny with the wind out of the east at 5 miles per hour (mph) and the temperature was 49°F.

Figure 1. Accident location at the end of the switchback.
